A slippery day in Gander - Seaboard and Western Geneva Airtrader

(by Robert G Pelley, 05 November 2017)

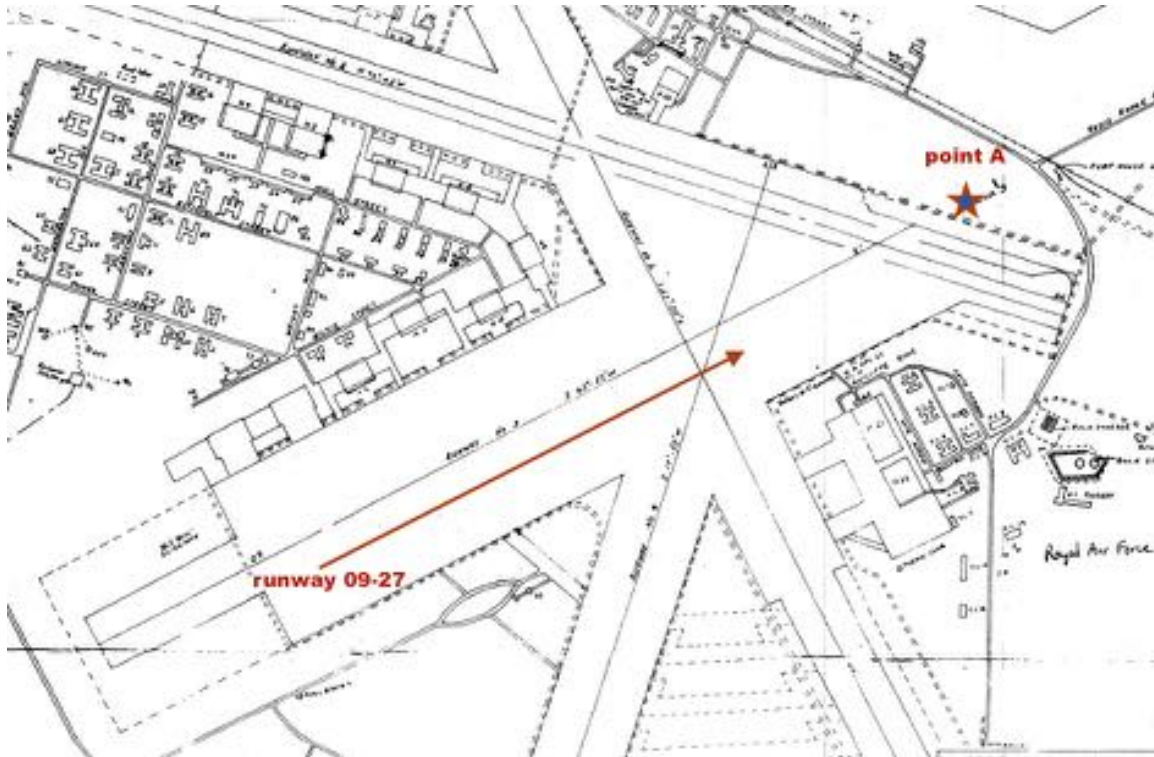
At about 1147 GMT, the aircraft contacted Gander Tower and was cleared for a standard Instrument Landing System approach on runway 09. The aircraft touched down in what appeared a normal manner - but continued down past the end of the runway. It then rolled about 55-60 meters over half-frozen earth and then crossed and hung up on a ditch about 6-7 meters wide.

In any case, he ended up roughly at point A on the previous map.

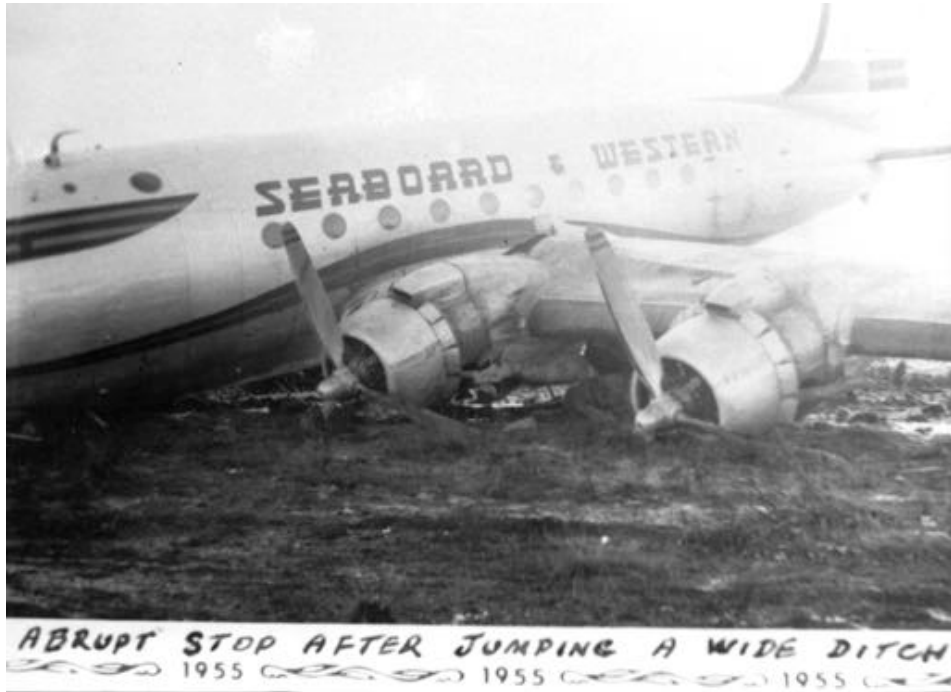
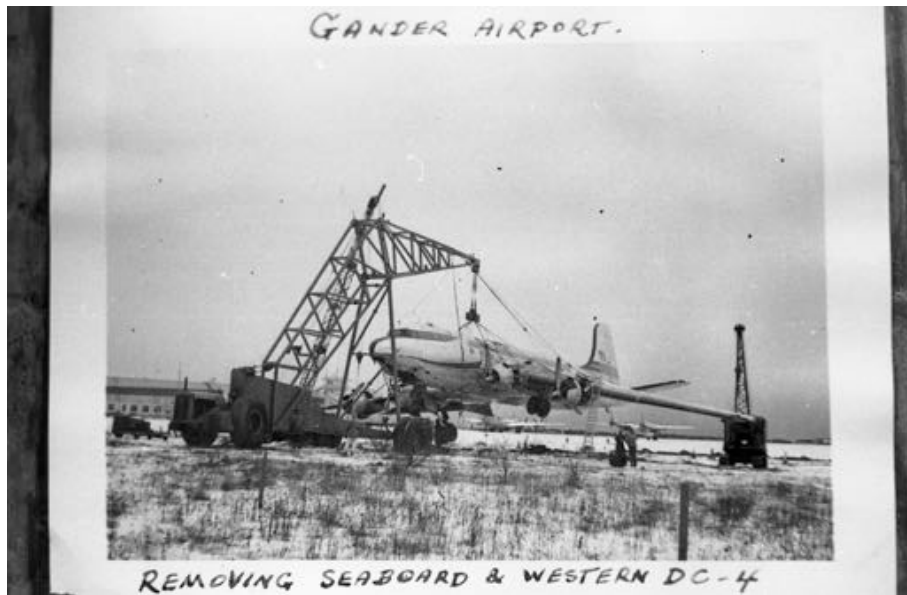
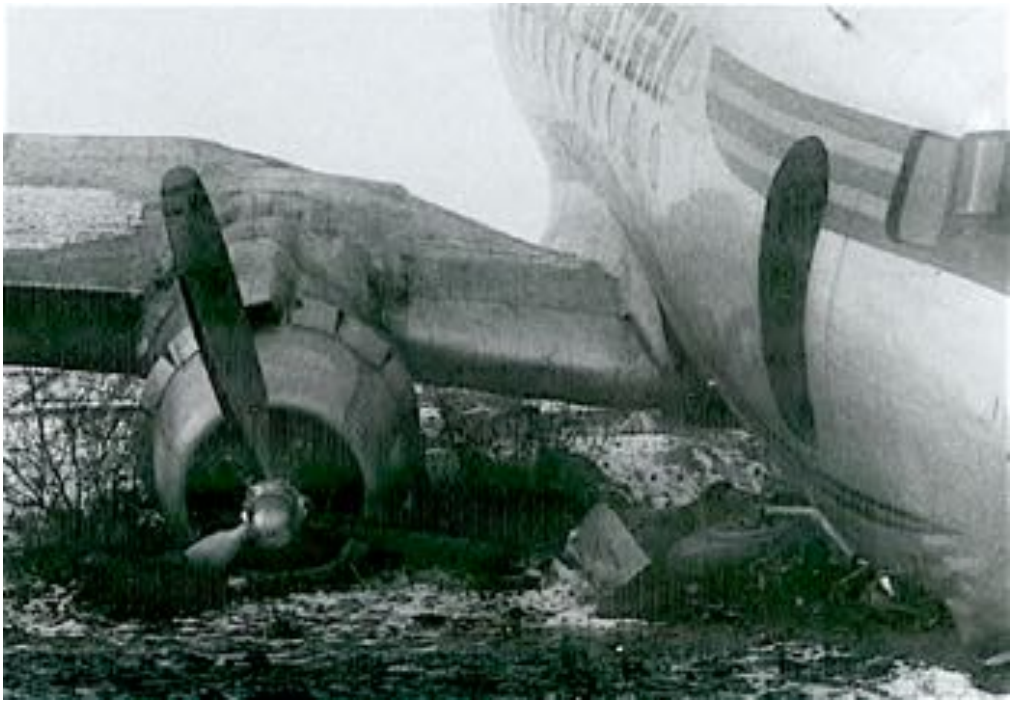
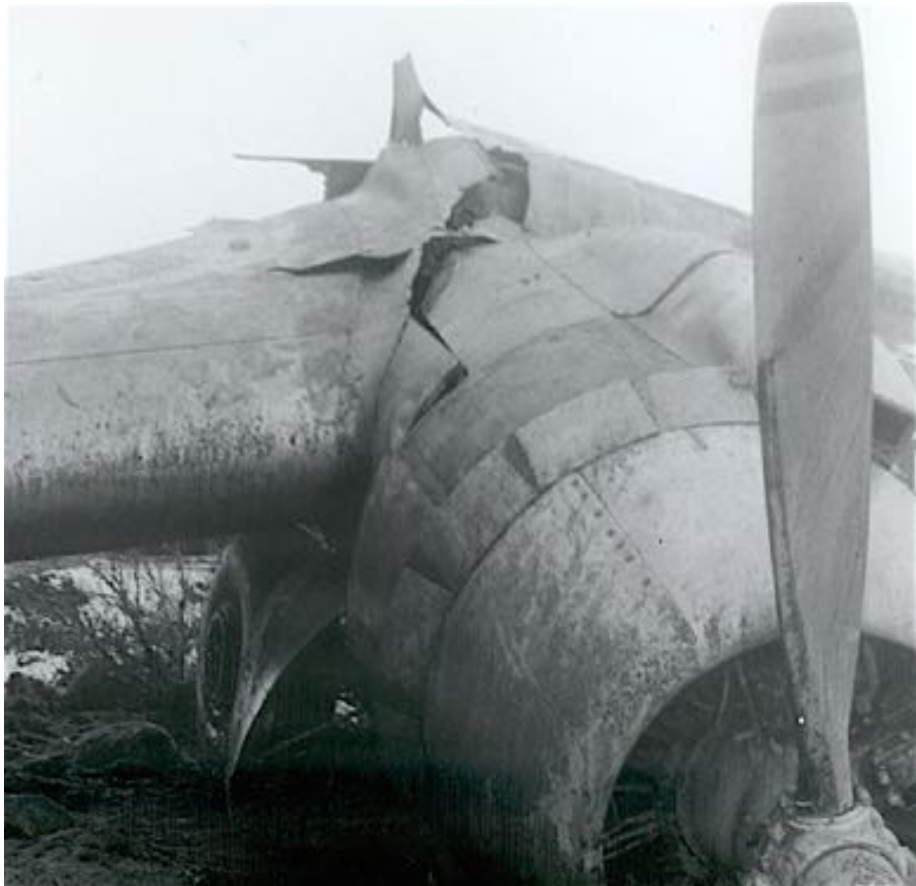
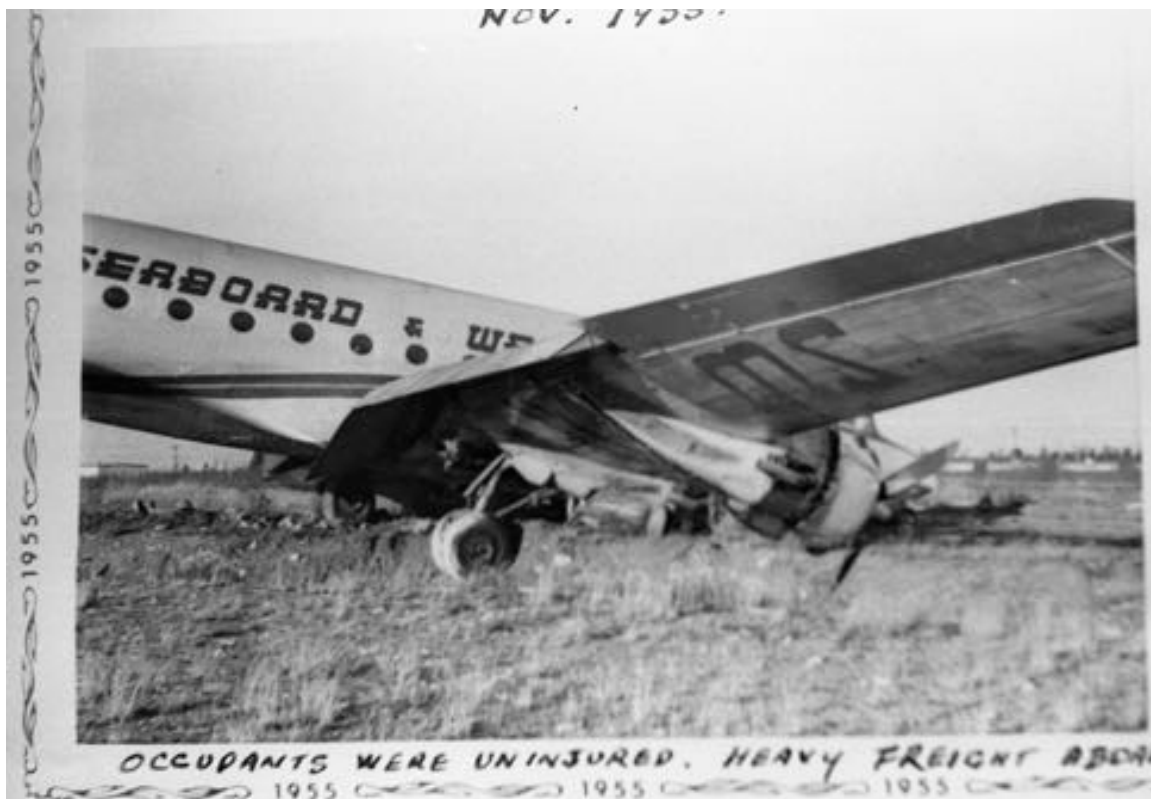
1. Engines: (with possible other major damage to all four engines)

| No 1 | Lower cowling and oil cooler, underside of nacelle |
| No 2 | Lower cowling and oil cooler. Bottom cylinders damaged. Nacelle twisted approximately 15° and separated at the firewall. |
| No 3 | Lower cowling and oil cooler. Nacelle twisted approximately 10°. |
| No 4 | Lower cowling slightly damaged |

| All blades have major damage. Domes and propeller assembly to be overhauled and magnifluxed. |

| Nose Gear | Scrapped. Parts salvageable, subject to magnifluxing |
| Left Main Gear & Right Main Gear | Parts salvageable, subject to magnifluxing. |

| Center Section | Right wing pulled away from fuselage, from forward wing attach points. Possible other damage |
| Nose Section | Nose wheel upper truss torn out. Much cockpit floor damage |
| Interior of Cabin | Bulkhead pushed forward and broken in door area. Ceiling forward of door wrinkled. |

| Left Wing | Wing tip damaged forward bottom side. Main, center and rear spar areas broken, top skin opened and severely buckled upward. Immediate area of left gear destroyed. |
| Right Wing | Top skin buckled very badly. Front center and rear spar badly distorted, possible breaks. Bottom skin stub wing between #3 nacelle and fuselage severely damaged, spar and stress plates twisted and broken |
| Wing Flaps | Badly buckled, torn and deformed behind both inboard engines. |

Thanks is given to Darrell Hillier for several of the photos below, which let us better see the damages.
