Runway snow compaction

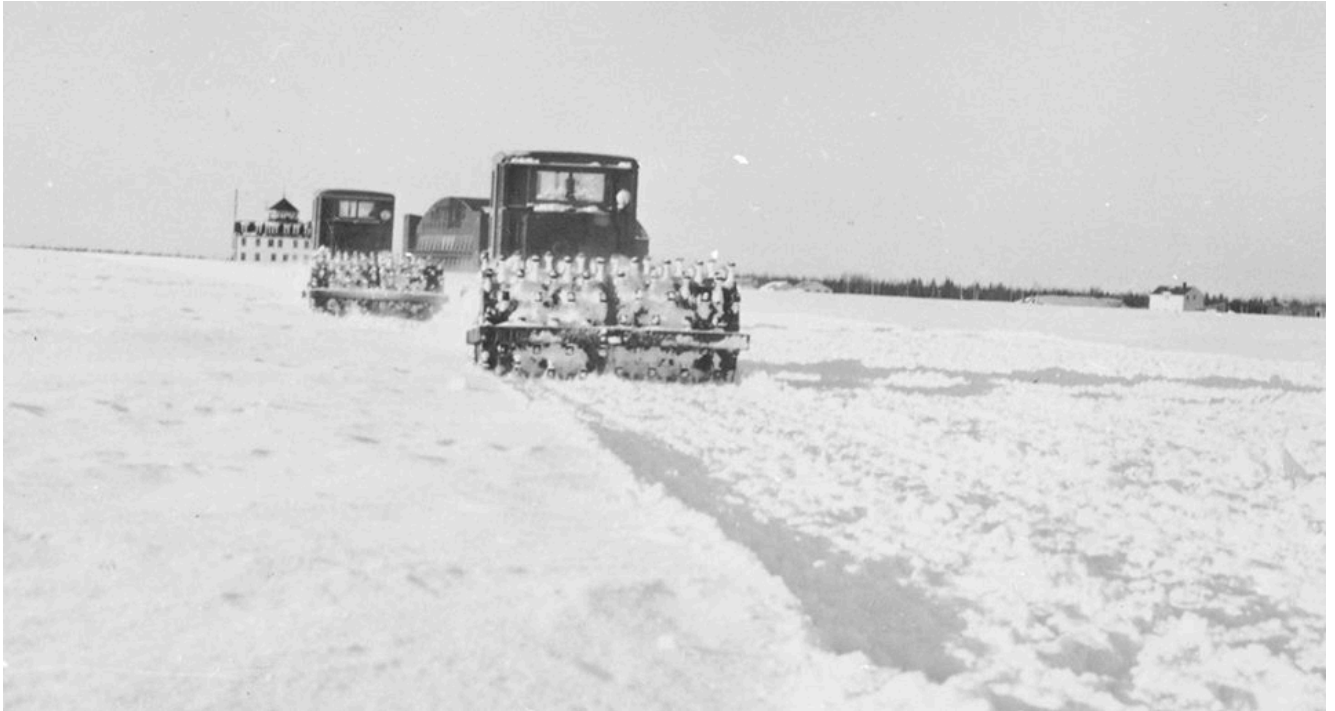
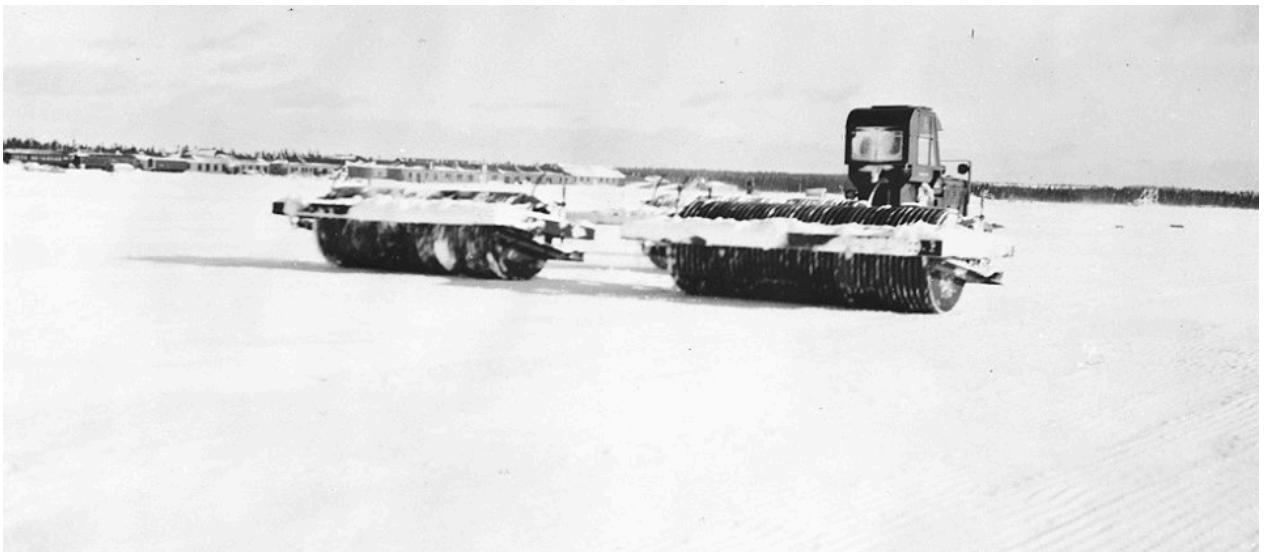
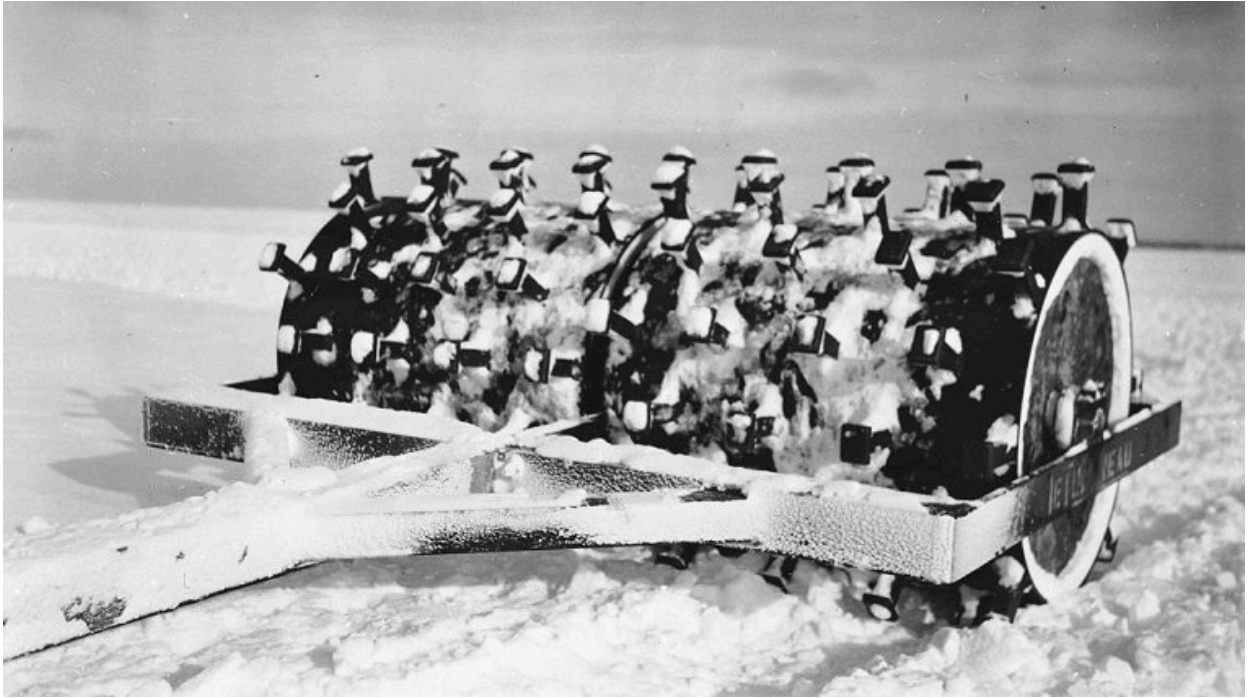
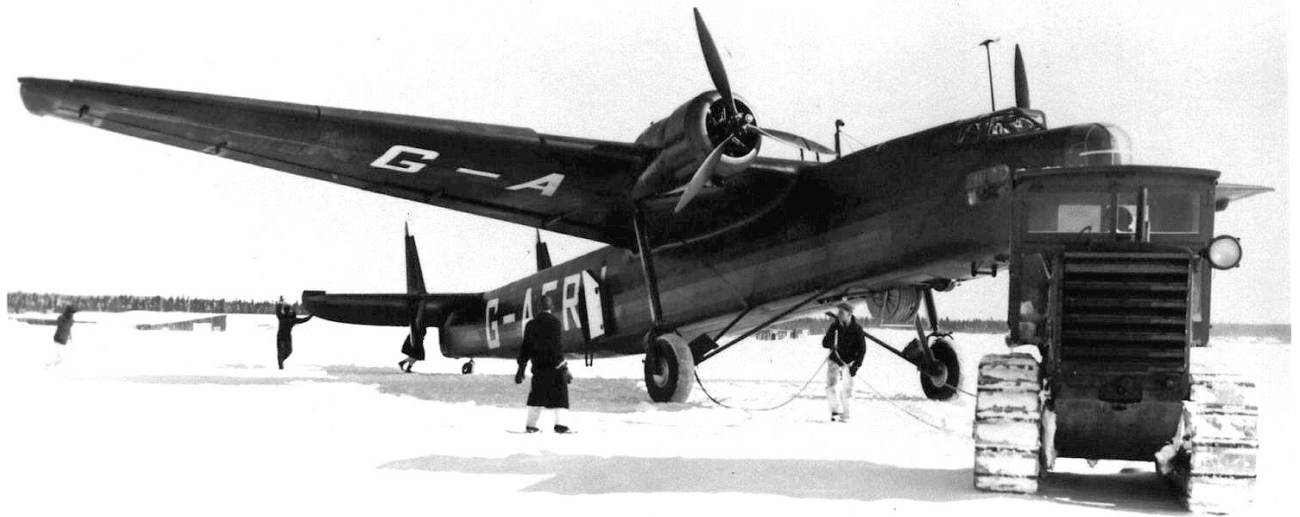
The following photos show the equipment and the type of plane. (Much thanks to Darrell Hillier on this article.)

By the winter of 1940 all test conditions were met. Compacting equipment was already available and there was a fair amount of snow. Two Harrow bombers had been converted for in-flight refueling but with the end of commercial civilian flying-boat traffic, they now were basically taking up ramp space. Might as well put them to good use!

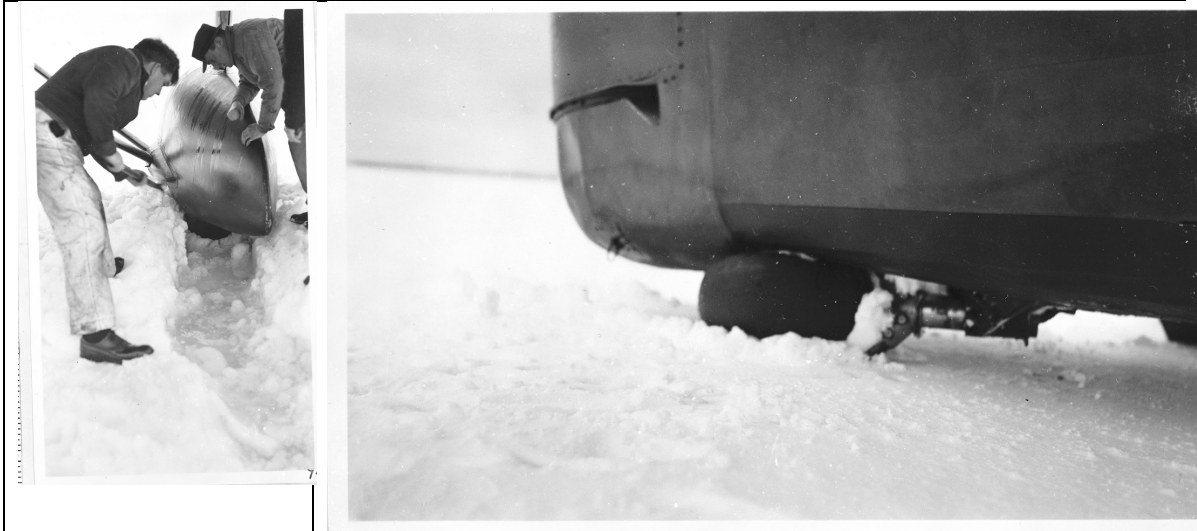
Talking about dents and dings, as an example, these photos show a tail-wheel mishap which occurred 19 March 1940 to Harrow G-AFRH, as confirmed in the operations log.

The tail wheel broke through a weak spot in compacted area. The crew given as Johnson and Le Chemenant (spelling being verified because hard to read).
